Diep River Sampling Report 09 May 2021

Makoya Amanzi Environmental Solutions CC

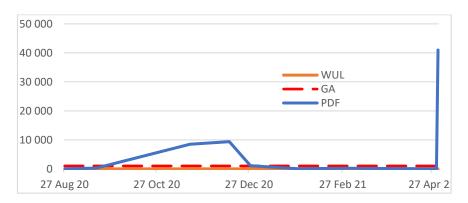
- This report cannot comment on the effectiveness or compliance of the plant's actual wastewater • works other than to report on their official discharge. Although hardly ever compliant with the Water Use Licence (WUL), and often not achieving "General Authorisation" (GA) limits as laid out in the "REVISION OF GENERAL AUTHORISATIONS IN TERMS OF SECTION 39 OF THE NATIONAL WATER ACT, 1998 (ACT NO. 36 OF 1998)", the official recorded discharge of the plant is not anticipated to be a major contributor.
- Our sample reference is PDF

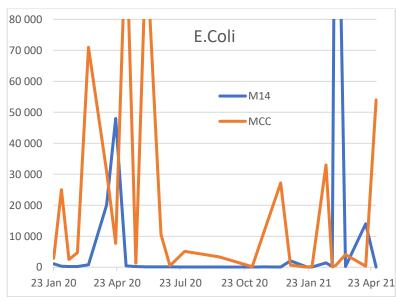
- It is often reported that a major source of the Diep River pollution is upstream from the Pots Dam Treatment Plant.
- However, although there may be pollution sources there, from the sampling, they are much lower than those downstream.
- Using the M14 Bridge as an up stream reference, and the Milnerton Canoe Club (MCC) as the lowest, it is very clear that, except for a few isolated samples, the water is far more polluted downstream.
- This does not excuse the pollution sources upstream, but does serve to highlight areas of higher priority.

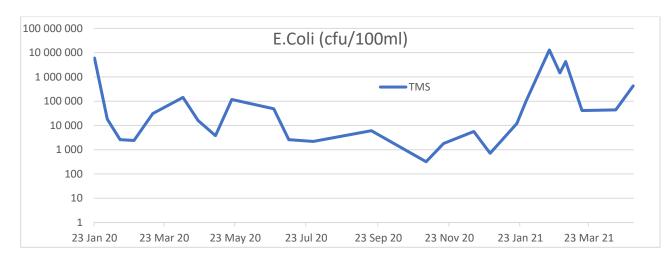
Theo Marais Stormwater Drain (TMS) 4.

- This channel is often highly polluted.
- The E.coli counts are often so high that they can only be graphically displayed with a logarithmic scale.
- The most obvious contributor is the adjacent lift station, however, this is not often observed to be malfunctioning, and most of the pollution seems to emanate from up stream.

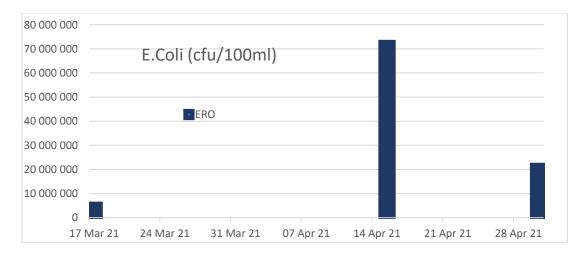
5. Erica Road Outlet (ERO)

- This is a well know outlet that is often reported to be dirty and with sewage odours.
- The sampling analyses has found the water to be excessively contaminated.
